**DEPARTMENT OF TRANSPORTATION****DIVISION OF ENGINEERING SERVICES**

Office of Structural Materials

Contract #: 04-0120F4Cty: SF/ALA Rte: 80 PM: 13.2/13.9File #: 99.28**WELDING INSPECTION REPORT****Resident Engineer:** Siegenthaler, Peter**Address:** 333 Burma Road**City:** Oakland, CA 94607**Report No:** WIR-020518**Date Inspected:** 10-Feb-2011**Project Name:** SAS Superstructure**OSM Arrival Time:** 700**Prime Contractor:** American Bridge/Fluor Enterprises, a JV**OSM Departure Time:** 1900**Contractor:** Zhenhua Port Machinery Company, Ltd (ZPMC) Chanxing Island**Location:** Shanghai, China**CWI Name:** Mr. LI YAN HUA**CWI Present:** Yes No**Inspected CWI report:** Yes No N/A**Rod Oven in Use:** Yes No N/A**Electrode to specification:** Yes No N/A**Weld Procedures Followed:** Yes No N/A**Qualified Welders:** Yes No N/A**Verified Joint Fit-up:** Yes No N/A**Approved Drawings:** Yes No N/A**Approved WPS:** Yes No N/A**Delayed / Cancelled:** Yes No N/A**Bridge No:** 34-0006**Component:** OBG Segment**Summary of Items Observed:**

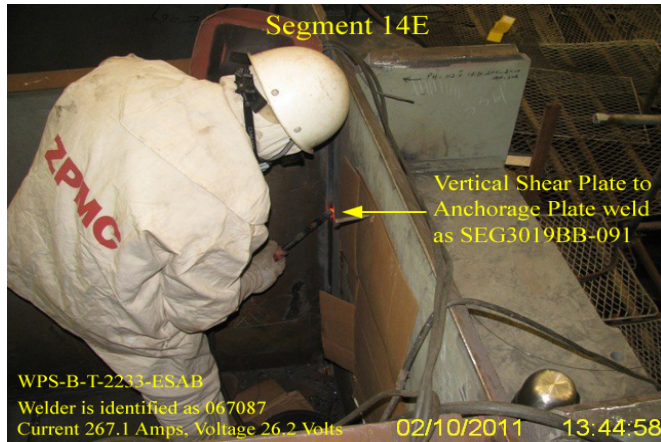
ZPMC welding personnel performing Flux Core Arc Welding of Complete Joint Penetration welds joining the vertical shear plate to anchorage plate weld joint located on 14E at bike path side. The weld is designated as SEG3019BB-091. The welder is identified as 067087. ZPMC QC Mr. GUO SHI HUI was onsite monitoring the welding variables. The welding variables were recorded at, current 267.1 Amps, Voltage 26.2 Volts. The inprocess

Flux Core Arc Welding appears to be progressing in compliance with WPS-B-T-2233-ESAB. Further weld detail mention in attached picture.
